## ALABAMA DEPARTMENT OF TRANSPORTATION

Subject: Annual Inspection Report

Walker County-Bevill Field Airport

## ANNUAL INSPECTION REPORT

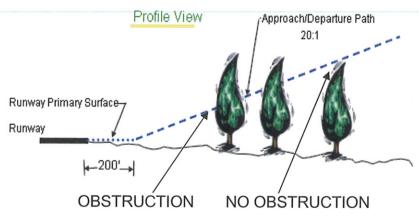
**APPENDIX 1**

Approach and Departure Path Dimensions				
Inner	Outer			
Width	Width	Length	Acreage	
250 Feet	450 Feet	1,000 Feet	8.04 Acres	
Primary Surface Dimensions				
250 Feet Wide Centered Along Runway Centerline				
Extending 200 Feet Past the Runway End				
Runway Safety Area Dimensions				
120 Feet Wide Centered Along Runway Centerline				
Extending 200 Feet Past the Runway End
